# Inventory & Schedule of Condition

123 Sample Street  
Sample City  
Sampleshire  
AB1 2CD

**April  
23rd 2019**

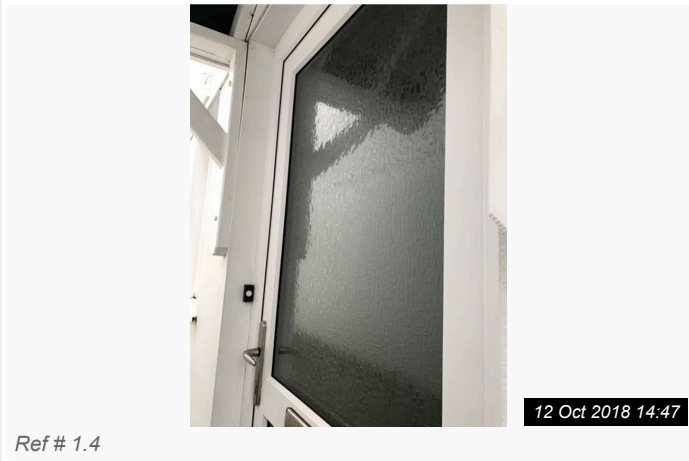
| 1. EXTERIOR FRONT (CONT.) | | | |
|---|---|---|---|
| Ref # 1.4 | | 12 Oct 2018 14:46 | |

| 1. EXTERIOR FRONT | | | |
|---|---|---|---|
| 1.4 Main Entrance door and frame | White UPVC double glazed door with 2 double glazed panes, Stainless steel locking lever handle and letter flap. Matching white UPVC frame. | Light tarnishing to exterior letter flap. | |
