# Inventory & Schedule of Condition

123 Sample Street  
Sample City  
Sampleshire  
AB1 2CD

**April  
23rd 2019**

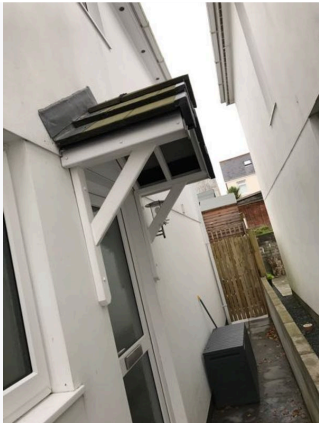
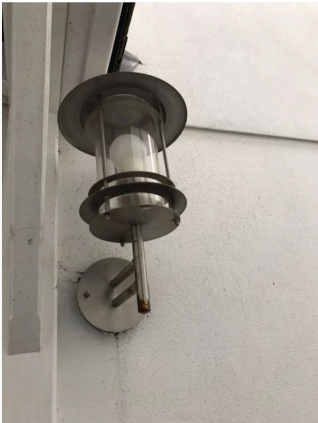
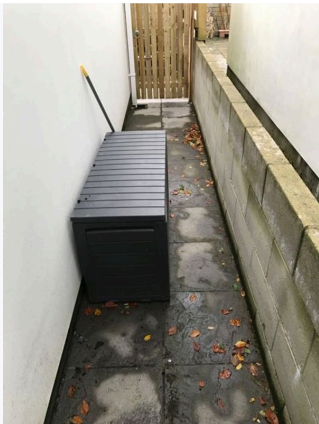
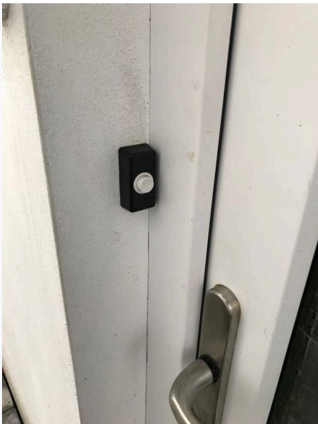
| 1. EXTERIOR FRONT (CONT.) | | | |
|---|---|---|---|
| Ref # 1.3 | | 12 Oct 2018 14:46 | |

| 1. EXTERIOR FRONT | | | |
|---|---|---|---|
| 1.3 Door numbers, door bells, exterior lights etc. | 4 stainless steel exterior lights. ;<br>Green wheelie bin;<br>Black recycle box with bags. ;<br>Clear glass effect numeral. ;<br><br>Black plastic storage box. ;<br>Door bell. | Lights are operational | |

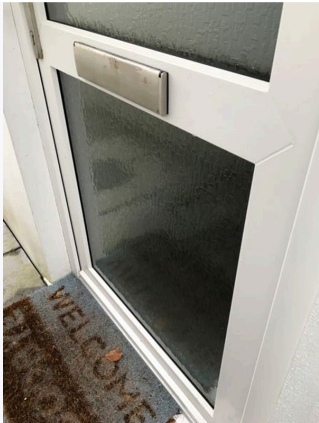
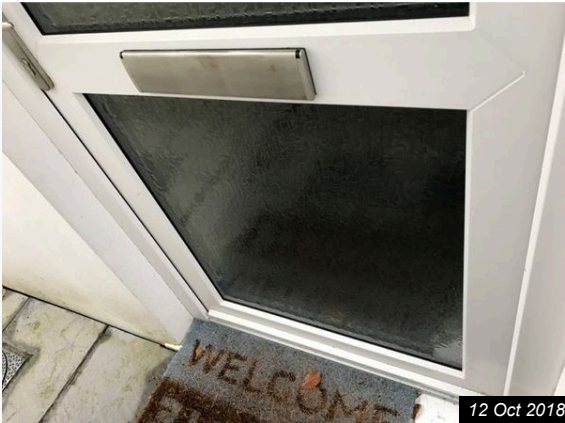
| 1. EXTERIOR FRONT (CONT.) | | | |
|---|---|---|---|
| Ref # 1.4 | | 12 Oct 2018 14:46 | |

| 1. EXTERIOR FRONT | | | |
|---|---|---|---|
| 1.4 Main Entrance door and frame | White UPVC double glazed door with 2 double glazed panes, Stainless steel locking lever handle and letter flap. Matching white UPVC frame. | Light tarnishing to exterior letter flap. | |

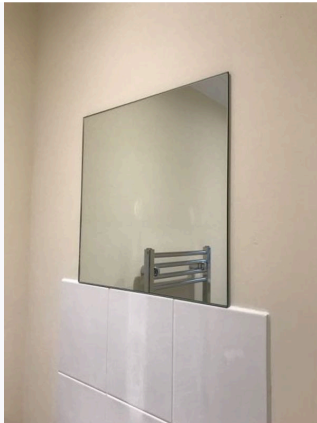
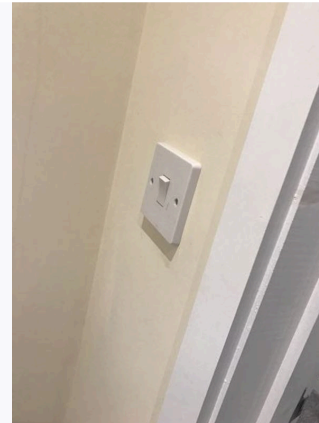
Ref # 3.8

| Item | Description | Condition | Tenant Comments |
|---|---|---|---|
| 3.8 Fixtures/Fittings | 1 chrome coloured toilet roll holder<br>1 wall mounted extractor fan<br>1 fan isolation switch<br>1 mirror<br>1 single light switch | No defects noted | |

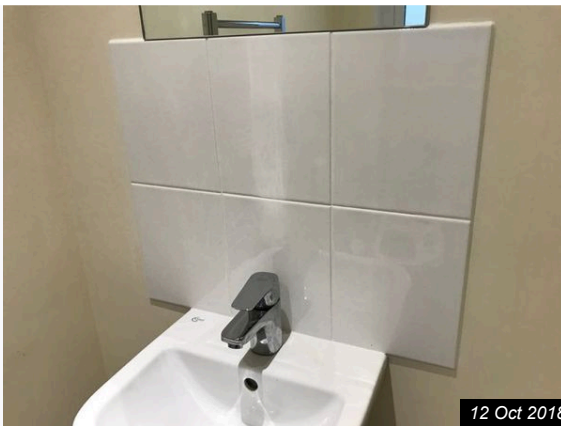
Ref # 3.9

| Item | Description | Condition | Tenant Comments |
|---|---|---|---|
| 3.9 Tiles | White tiles with white grout | No defects noted | |

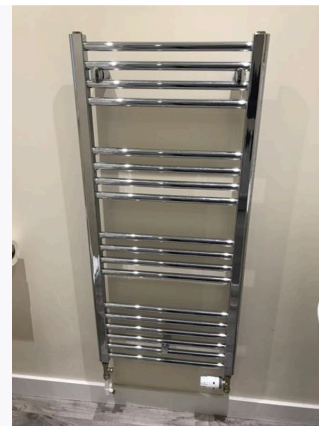
Ref # 3.10

| 3. CLOAKROOM/TOILET (CONT.) | | | |
|---|---|---|--|
| 3.10 Heating | Chrome coloured heated towel rail with valve and thermostat present | No defects noted | |

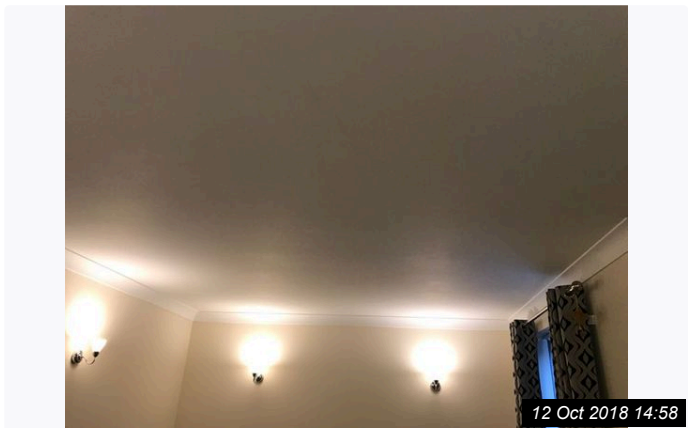
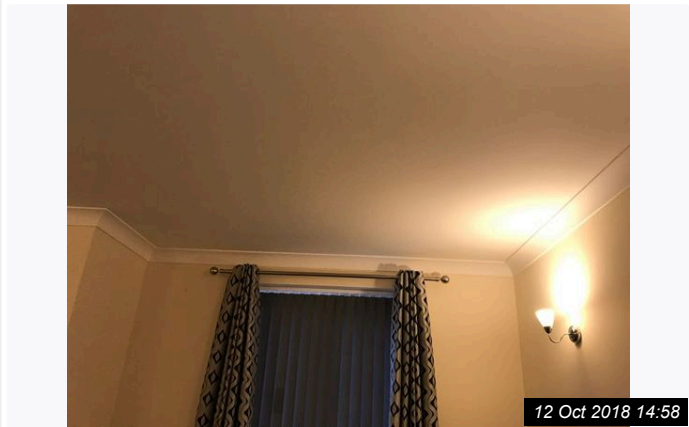
Ref # 4.2

| Item | Description | Condition | Tenant Comments |
|---|---|---|---|
| 4.2 Ceiling | Ceiling is smooth plaster painted white. Coving is painted white | No defects noted | |

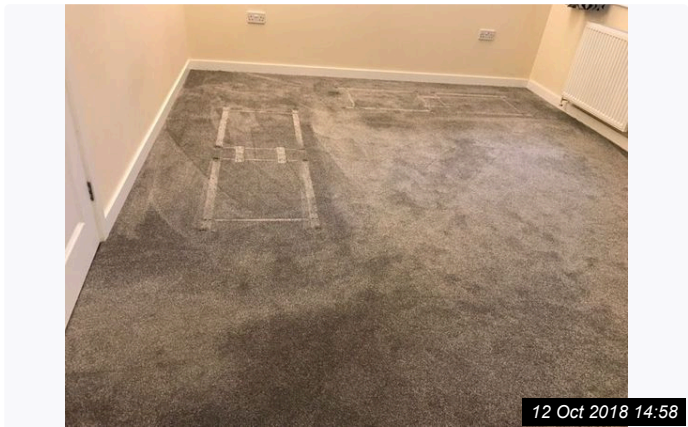
Ref # 4.3

| Item | Description | Condition | Tenant Comments |
|---|---|---|---|
| 4.3 Flooring | Grey fitted carpet | Furniture indentations<br>No stains noted | |

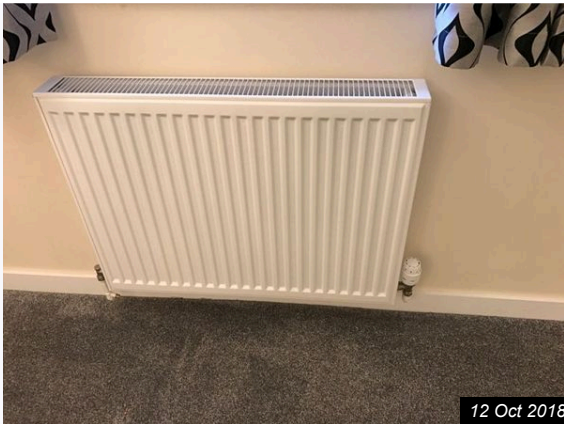
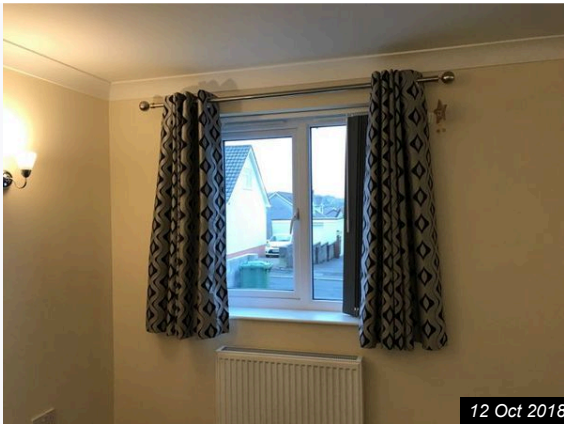
Ref # 4.4

| Item | Description | Condition | Tenant Comments |
|---|---|---|---|
| 4.4 Heating | 2 white double panel radiators with thermostats | No defects noted | |

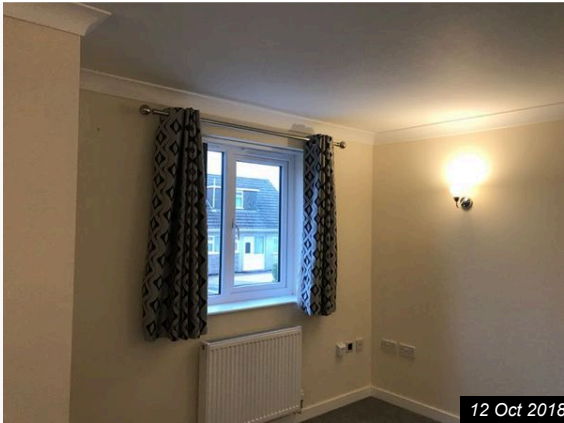
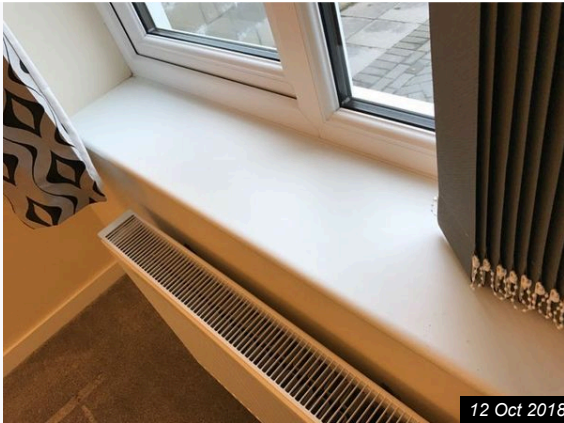
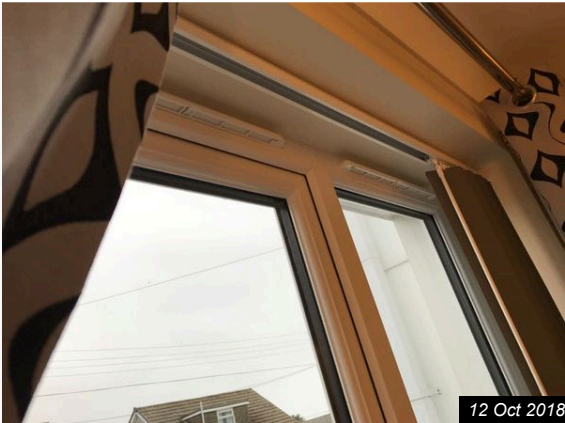
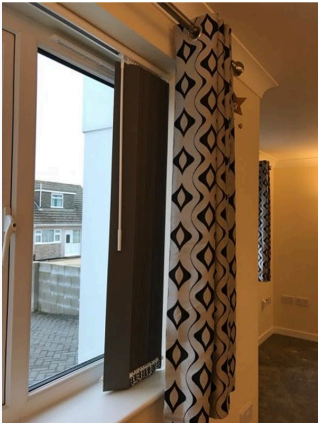
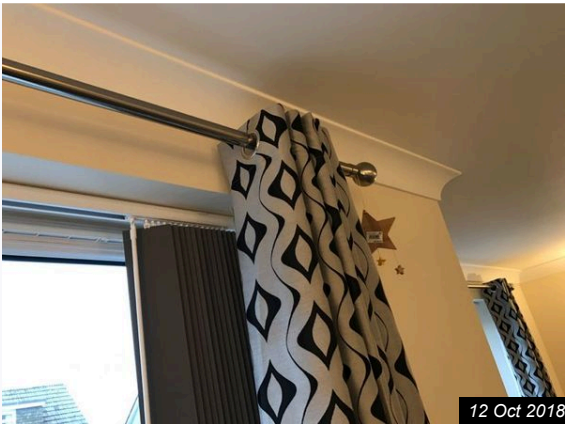
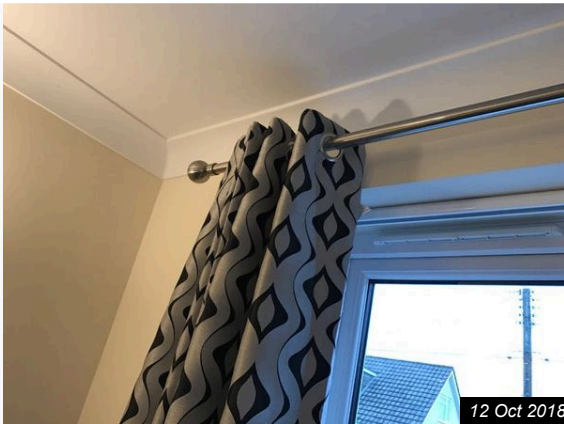
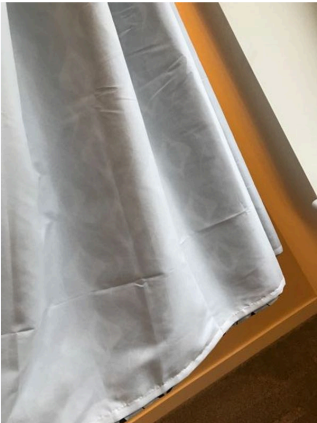
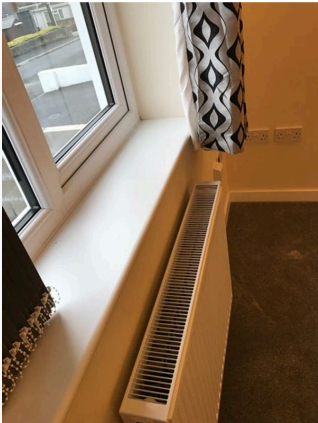
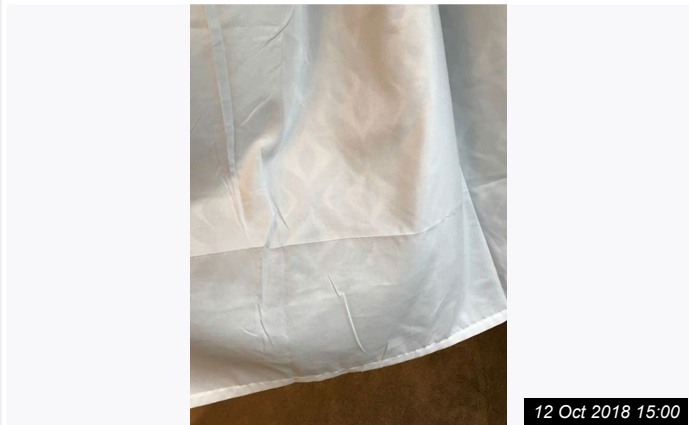
Ref # 4.5

| 4. LIVING ROOM/LOUNGE (CONT.) | | | |
|---|---|---|--|
| 4.5 Windows | 2 white uPVC double glazed windows each with 1 fixed pane, 1 opening pane, 1 white locking handle<br>White MDF window sill<br>2 white plastic trickle vents<br>Grey vertical blinds with plastic chain connectors and pole controls<br>Each window has a stainless steel curtain rail with 2 finials<br>Pair of grey/black lined curtains | Excellent condition throughout<br>No defects noted | |

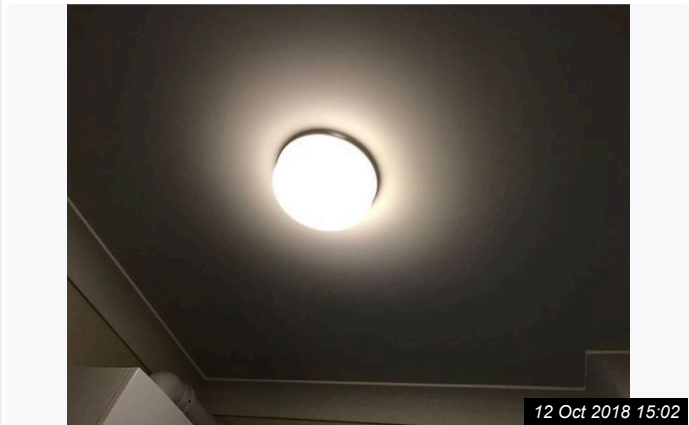
Ref # 5.2

| 5. UTILITY ROOM (CONT.) | | | |
|---|---|---|--|
| 5.2 Ceiling | Ceiling is smooth plaster painted white. Coving is painted white | No defects noted | |

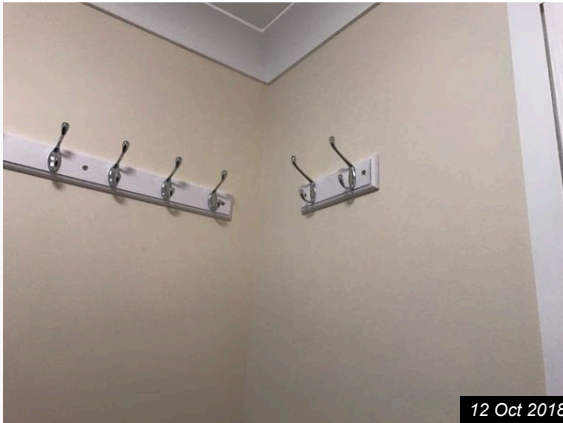
Ref # 5.9

| 5. UTILITY ROOM (CONT.) | | | |
|---|---|---|--|
| 5.9 Sockets/switches | 1 single light switch<br>1 carbon monoxide alarm<br>1 doorstop<br>3 fuse isolation switches<br>1 double socket<br>2 single sockets<br>1 fan isolation switch<br>1 small white coat rack with 2 chrome coloured hooks<br>1 large white coat rack with 6 chrome coloured hooks | No defects noted | |

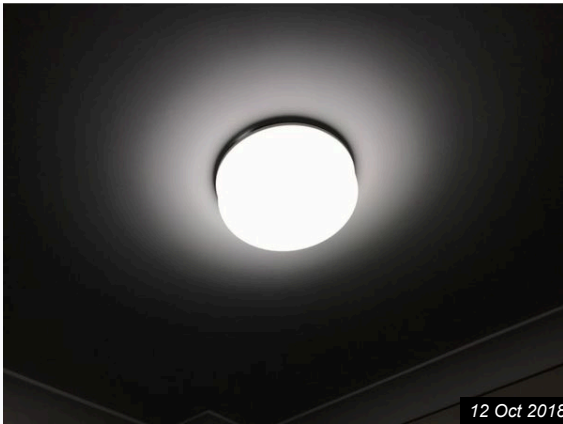
Ref # 5.10

| 5. UTILITY ROOM (CONT.) | | | |
|---|---|---|--|
| 5.10 Lights | 1 round enclosed ceiling light fitting | No defects noted<br>Light is operational | |

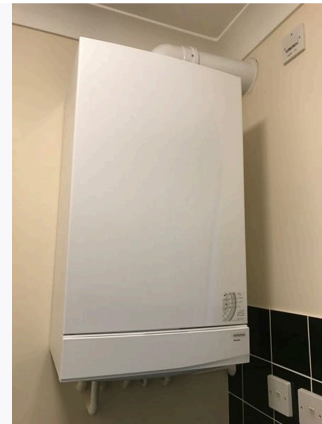
Ref # 5.11

| 5. UTILITY ROOM (CONT.) | | | |
|---|---|---|--|
| 5.11 Boiler/Alarms | 1 white Potterton Promax central heating boiler<br>1 carbon monoxide alarm | No defects noted | |

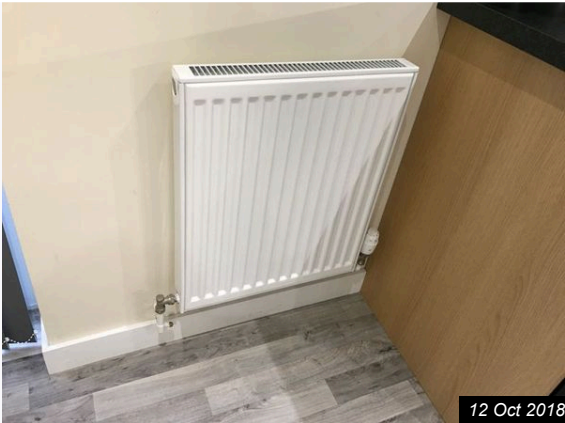
Ref # 6.4

| Item | Description | Condition | Tenant Comments |
|---|---|---|---|
| 6.4 Heating | 2 white double panel radiators with thermostats | No defects noted | |

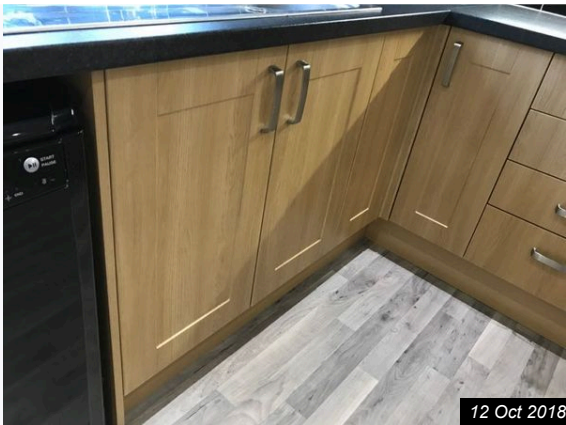
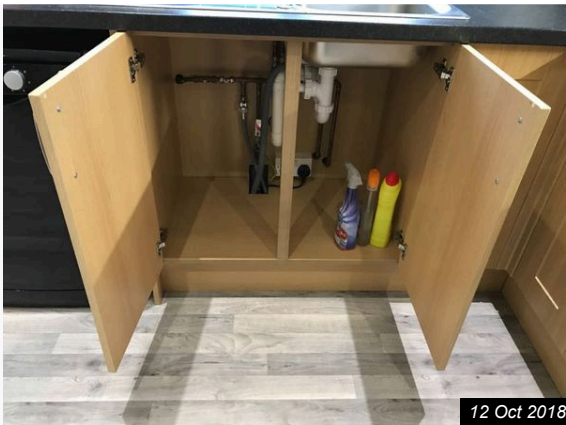
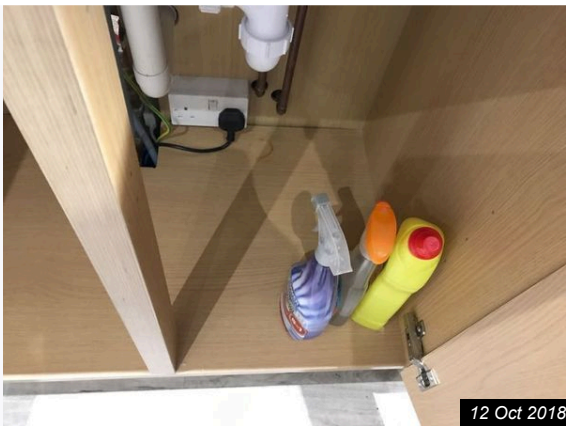
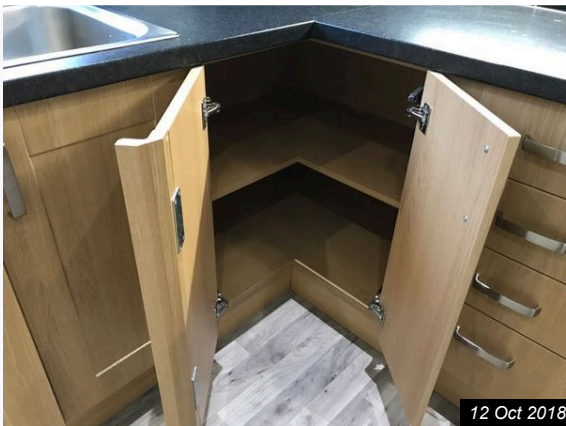
Ref # 6.8

| 6. KITCHEN/DINER (CONT.) | | | |
|---|---|---|--|
| 6.8 Cabinets | Wood effect units with wood effect doors and drawer fronts, stainless steel handles<br><br>Kitchen consists of:<br>1 tall unit with 5 shelves<br><br>Wall units from left - 1 double unit with 2 shelves<br>1 single unit with 1 shelf<br>1 single unit with 1 shelf<br>1 single unit with 1 shelf<br>1 double unit with 2 shelves<br><br>Base units from left - 1 appliance space with dishwasher<br>1 double sink unit - round rust mark to back of shelf<br>1 corner unit with 1 shelf<br>1 set of 4-drawers with grey plastic cutlery insert - light marks and scuffs to drawer bases<br>1 single unit with 1 shelf<br>1 appliance space with built under oven and filler panel below<br>1 double unit with 1 shelf<br>1 single unit with 1 shelf | All kitchen units are in excellent condition throughout<br>Please note that there are a few very light grubby marks to base unit doors and inside double unit to right of oven | |

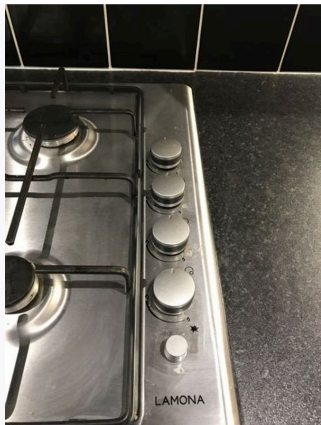
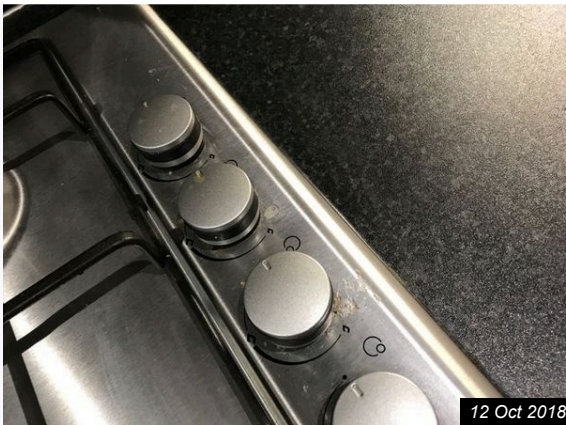
Ref # 6.11

| 6. KITCHEN/DINER (CONT.) | | | |
|---|---|---|--|
| 6.11 Hob | Stainless steel Lamona gas hob with 4 gas burners, 2 black pan supports, 4 black/grey control knobs, 1 ignition switch | Light grubby marks to control panel | |

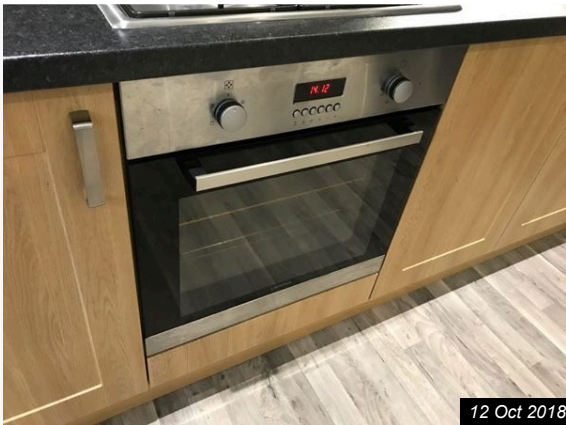
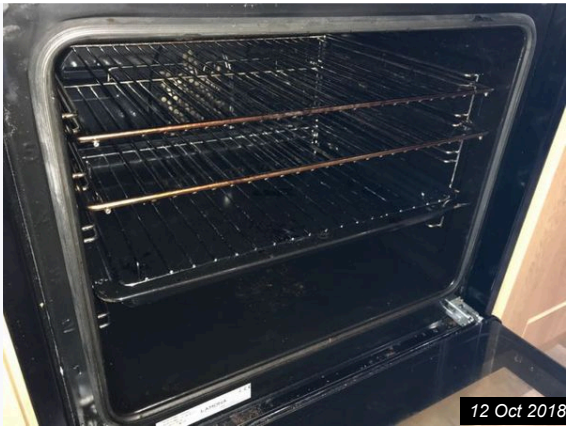
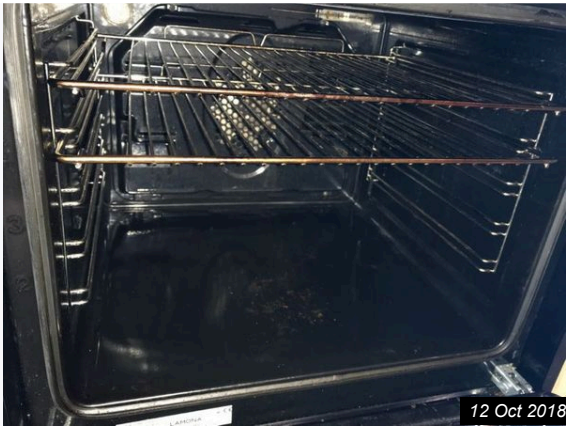
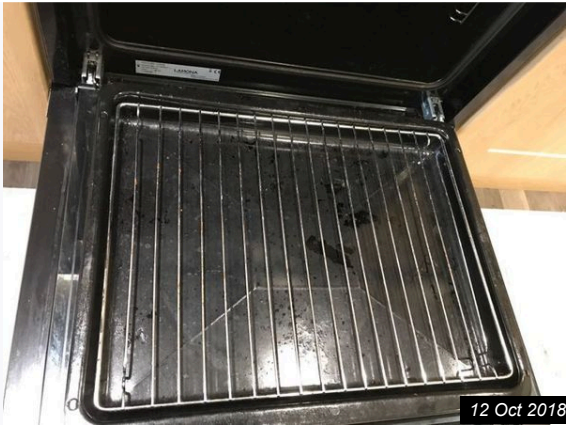
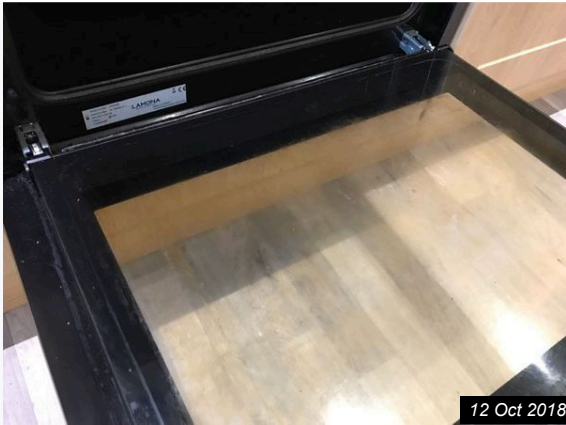
Ref # 6.12

| 6. KITCHEN/DINER (CONT.) | | | |
|---|---|---|--|
| 6.12 Oven | Black/stainless steel Lamona built under oven with 2 black/grey control knobs, 2 wire shelves, 1 black metal grill pan with wire rack | Oven has not been cleaned to a professional standard<br>Burnt on residue remaining to bars, base of oven and sides of oven<br>Burnt on residue remaining to grill pan and door interior | |

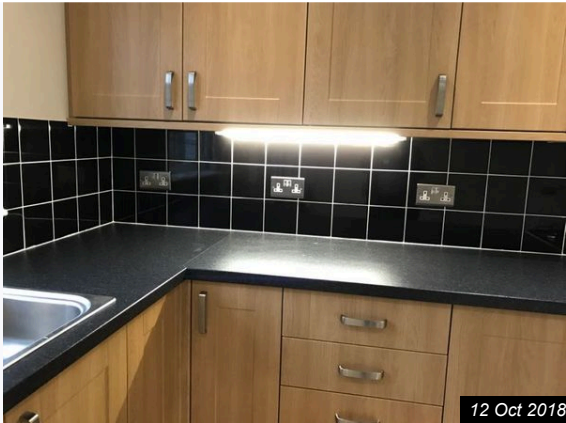
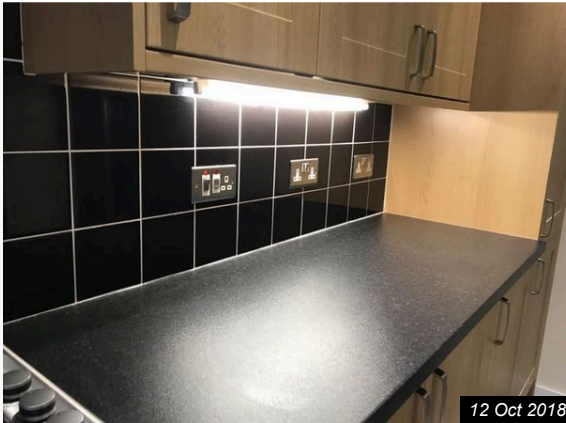
Ref # 6.15

| 6.15 Sockets/switches | 1 triple light switch<br>1 single light switch<br>1 TV aerial point<br>3 white plastic double sockets<br>5 stainless steel double sockets<br>1 stainless steel cooker switch with socket | No defects noted | |

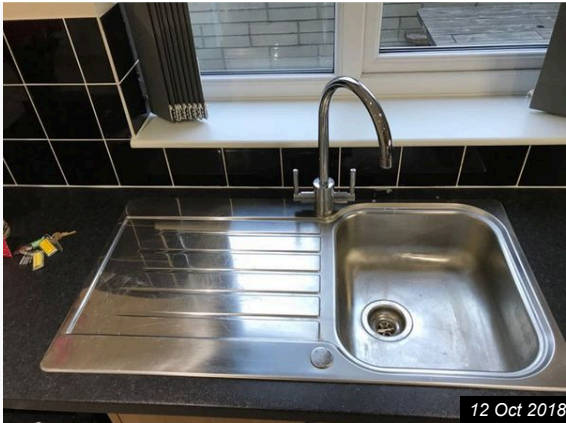
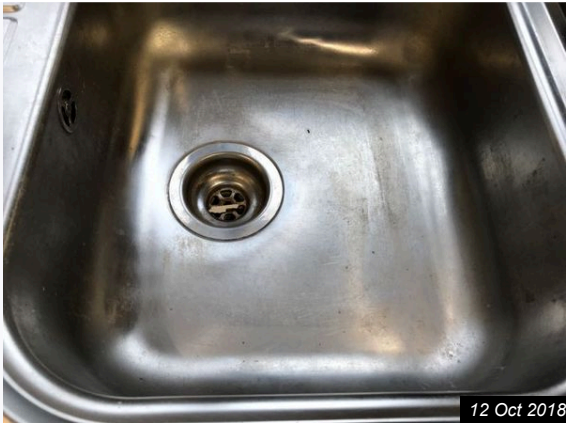
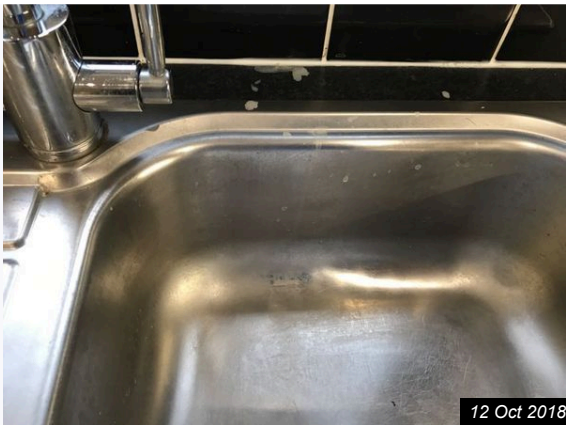
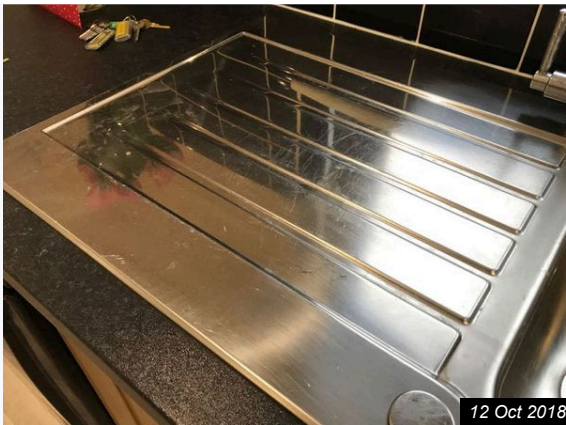
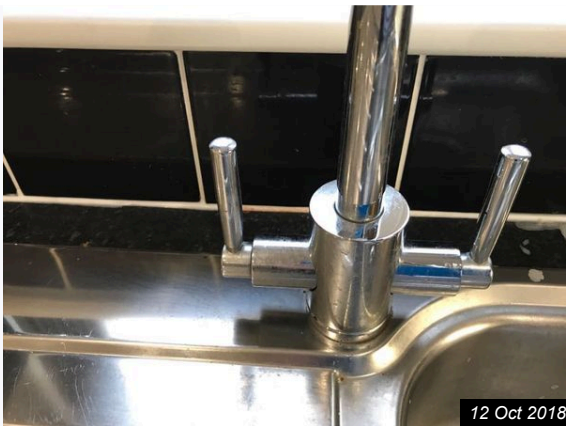
Ref # 6.17

| 6.17 Sink/Taps | Stainless steel 1.0 bowl sink with chrome coloured mixer tap | Sink is dirty marked<br>Drainer is lightly scratched throughout<br>Tap is dirty marked | |

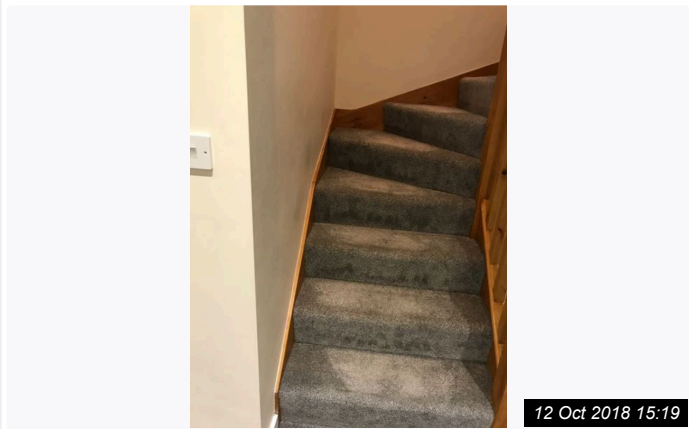
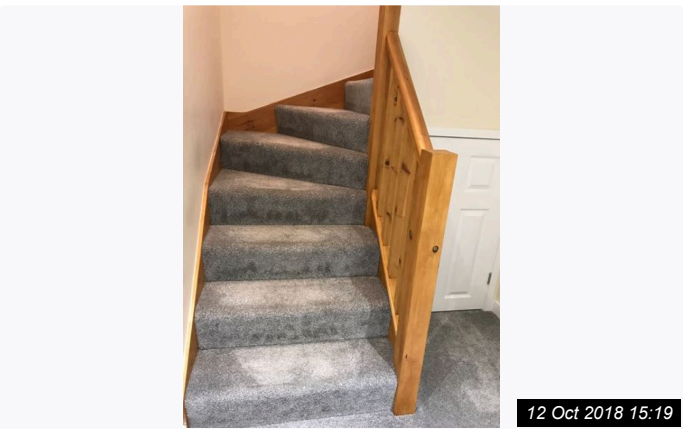
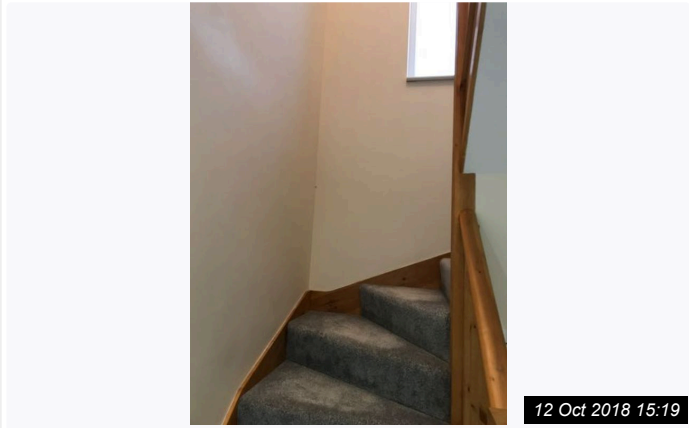
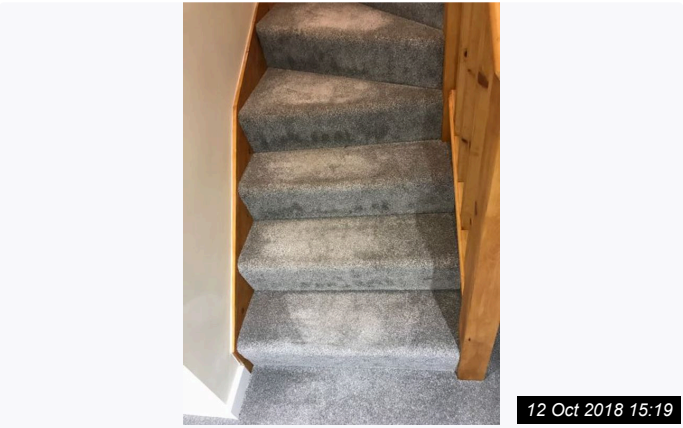
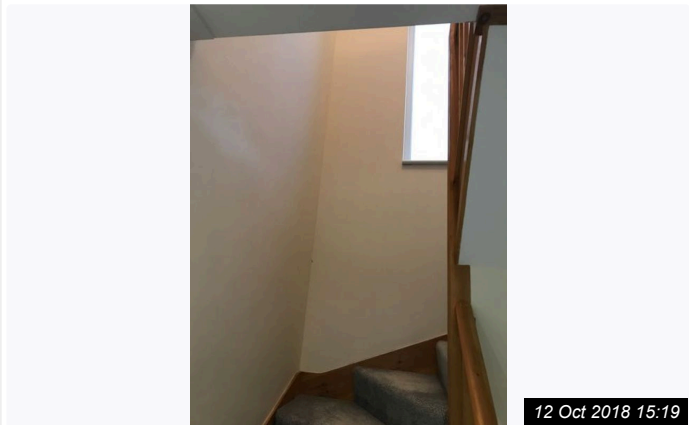
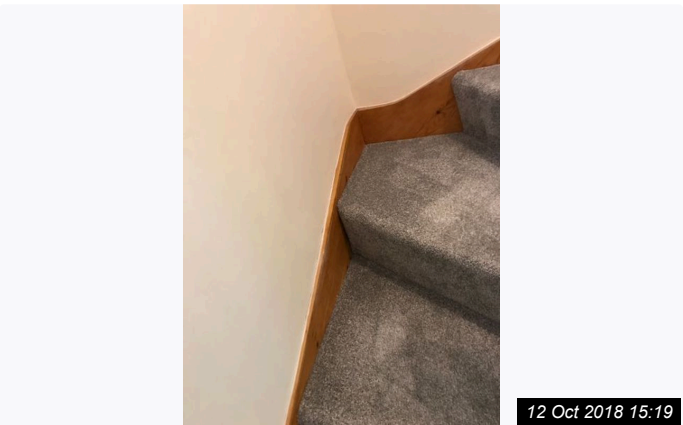
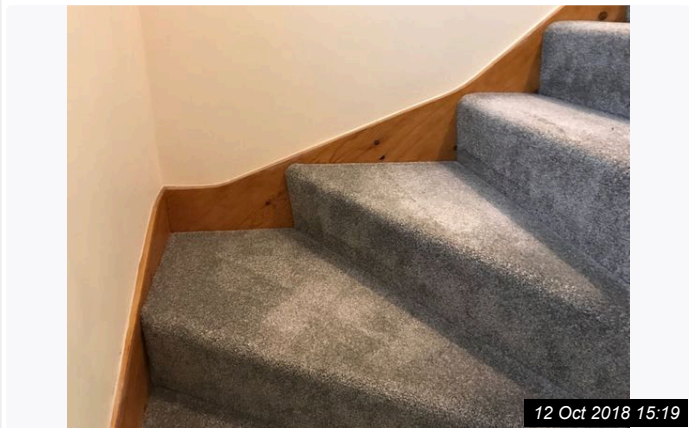
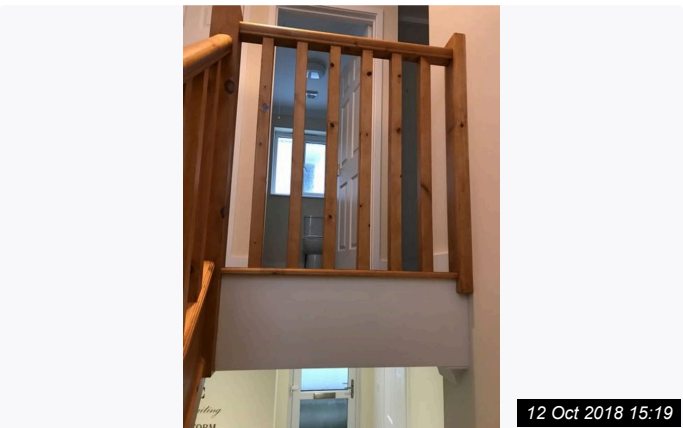
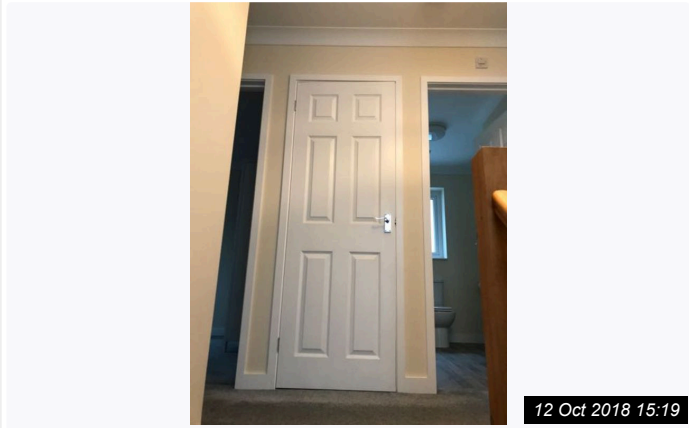
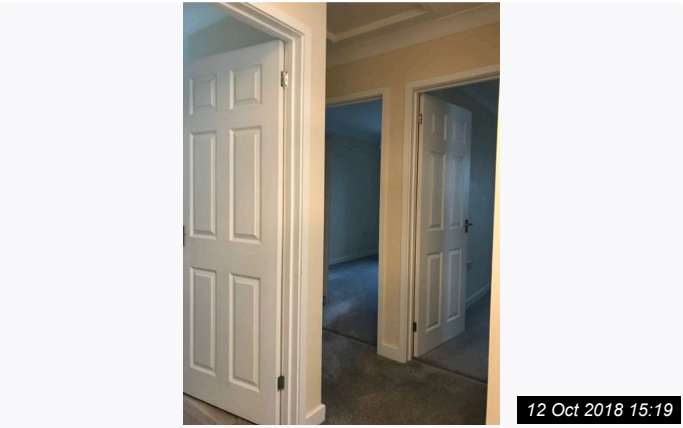
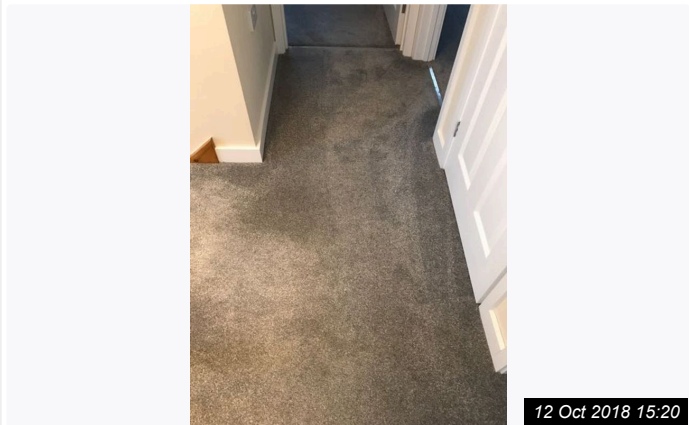
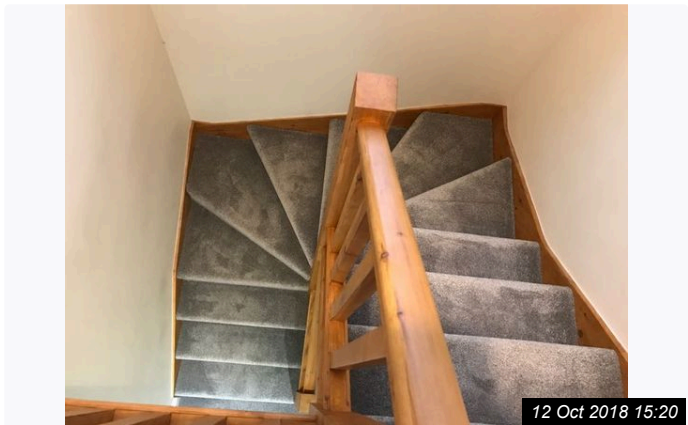
Ref # 7.1

| Item | Description | Condition | Tenant Comments |
|---|---|---|---|
| 7.1 Walls and skirting | Walls are smooth plaster painted cream. Skirting on stairs are varnished. Skirting on landing is painted white | Light chips to corners of walls<br>1 brass coloured picture hook<br>Light scuffs throughout lower walls<br>Cracks to bottom of walls above skirting on stairs | |

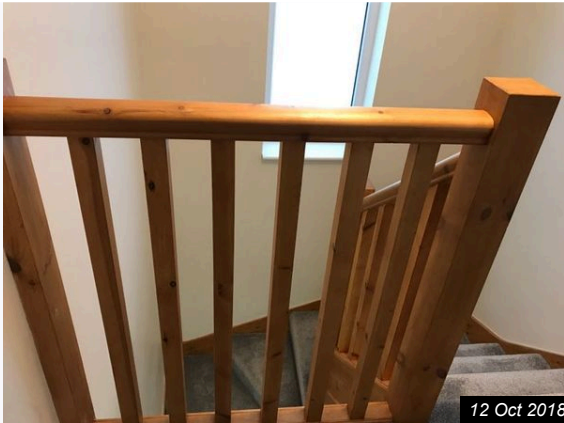
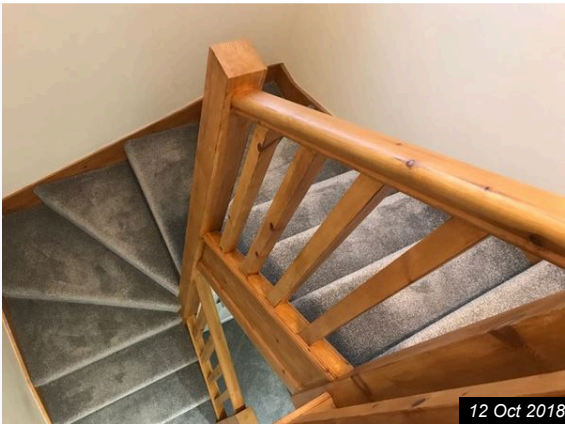
Ref # 7.4

| Item | Description | Condition | Tenant Comments |
|---|---|---|---|
| 7.4 Banister/Handrail | Wooden banister and handrail varnished | No defects noted | |

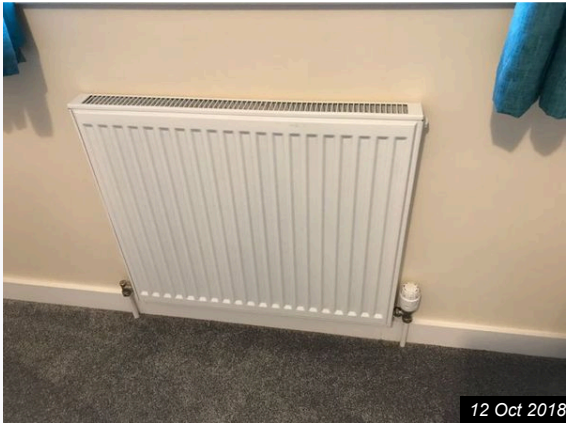
Ref # 8.6

| 8.6 Heating | White single panel radiator with valve and thermostat present | No defects noted | |

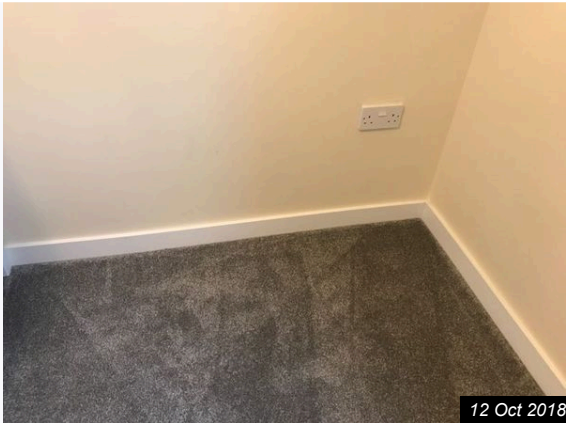
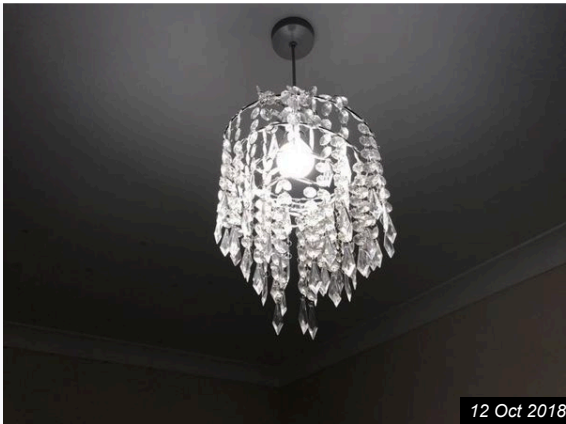
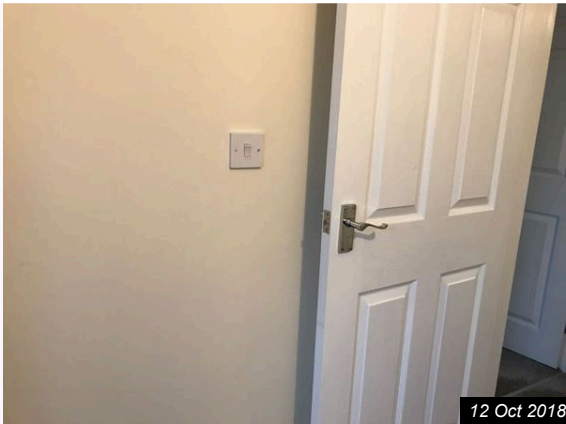
Ref # 8.7

| 8.7 Lights/Sockets/Switches | 1 white plastic pendant light fitting with wire shade with glass bead decoration<br>1 single light switch<br>1 doorstop<br>2 double sockets visible | No defects noted<br>Light is operational | |

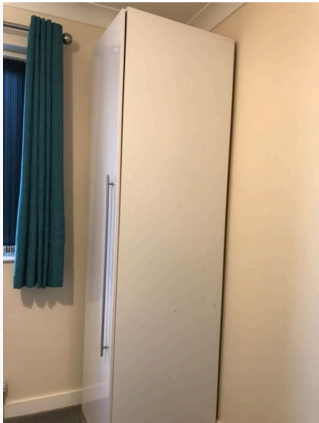
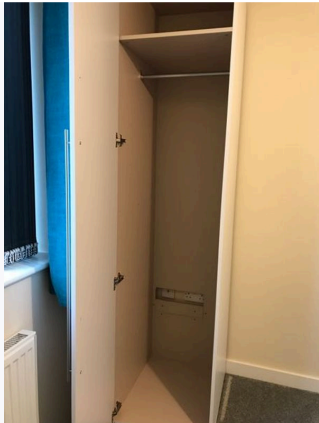
Ref # 8.8

| 8.8 Wardrobe | Large white freestanding wardrobe with white gloss door, stainless steel handle, 1 shelf, 1 hanging rail | Cut out to back panel for sockets<br>4 fixing holes to right side end panel | |

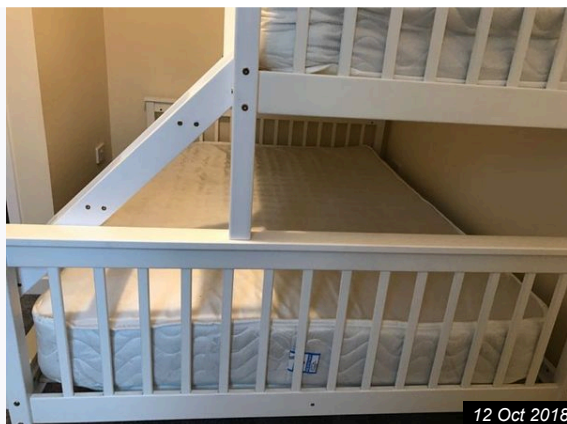
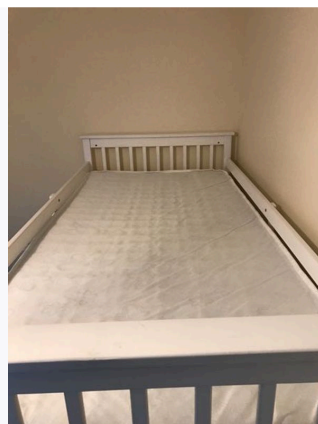
Ref # 8.9

| 8.9 Bed | White wooden framed bunk bed with 1 single bed and 1 double bed, 2 mattresses present | Purchased by tenant<br>No defects noted | |

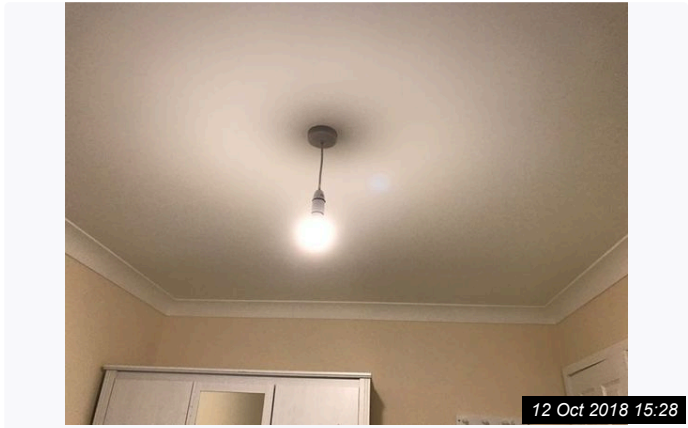
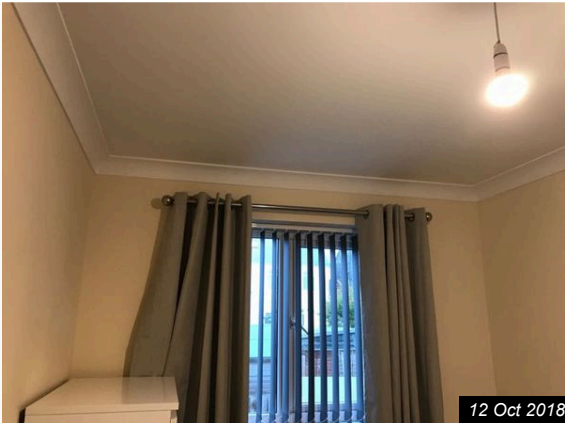
Ref # 9.2

| Item | Description | Condition | Tenant Comments |
|---|---|---|---|
| 9.2 Ceiling | Ceiling is smooth plaster painted white. Coving is painted white | No defects noted | |

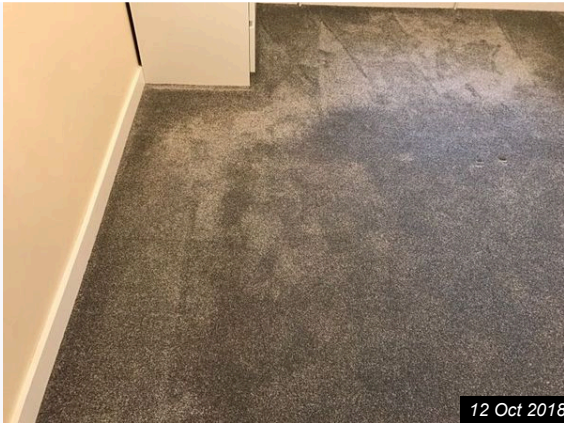
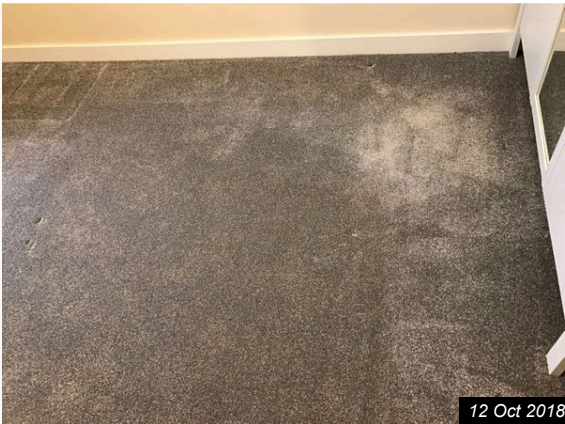
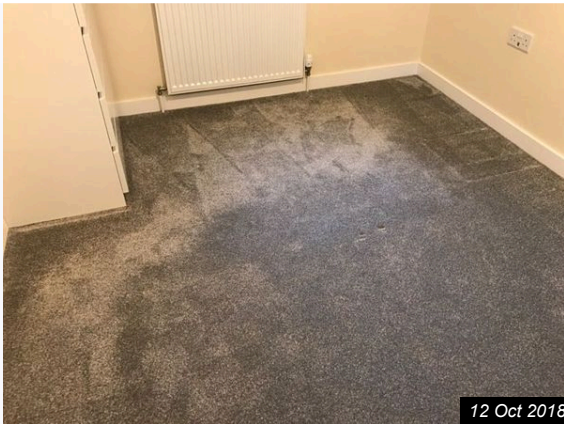
Ref # 9.3

| Item | Description | Condition | Tenant Comments |
|---|---|---|---|
| 9.3 Flooring | Grey fitted carpet | No defects noted | |

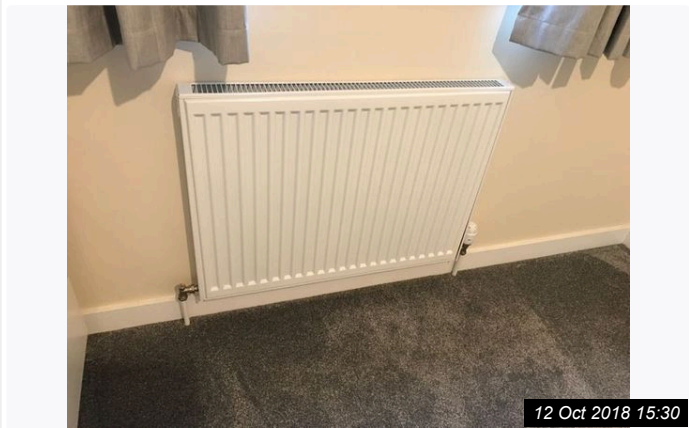
Ref # 9.6

| Item | Description | Condition | Tenant Comments |
|---|---|---|---|
| 9.6 Heating | White single panel radiator with thermostat | No defects noted | |

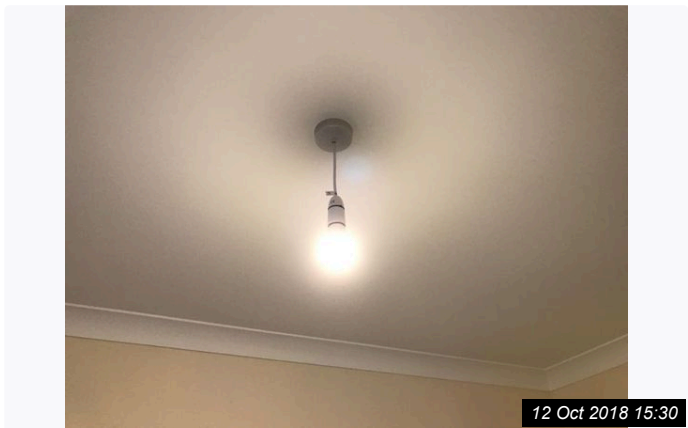
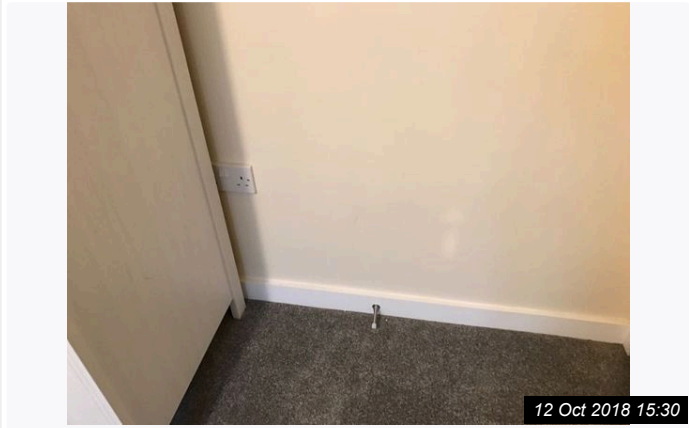
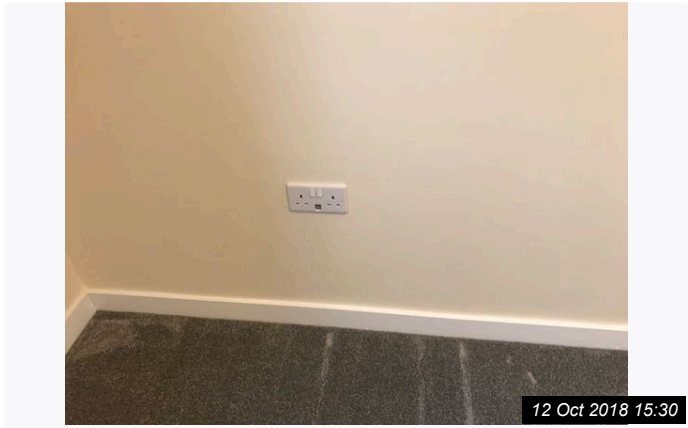
Ref # 9.7

| 9.7 Lights/Sockets/<br>Switches | 1 white coat rack<br>1 white plastic pendant light fitting with bulb<br>1 single light switch<br>1 doorstop<br>2 double sockets<br>1 double socket with USB | No defects noted<br>Light is operational | |

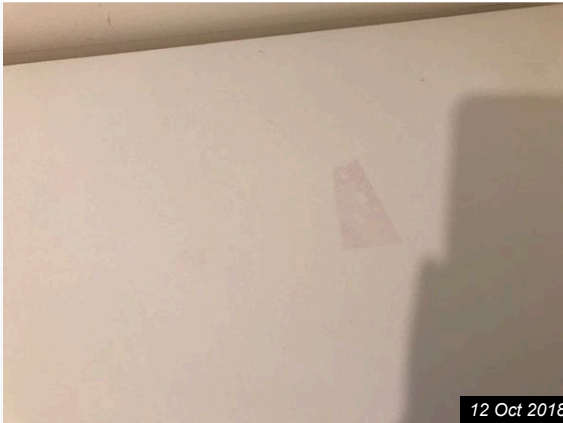
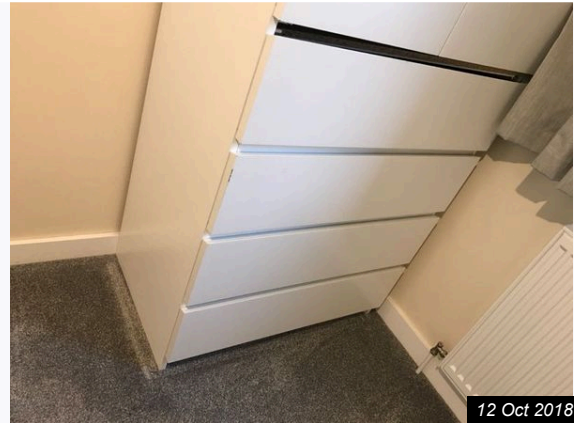
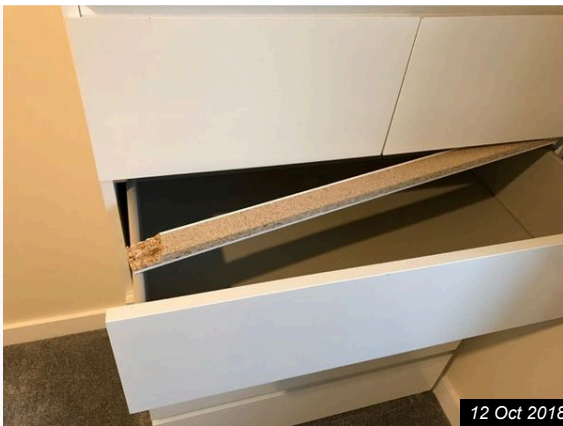
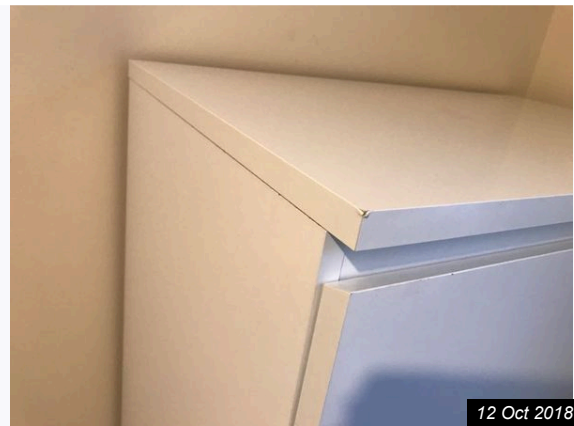
Ref # 9.9

| 9.9 Drawers | White 6-drawer chest with integrated handles | Drawers are dusty and dirty inside<br>Pink staining to top - 6cm<br>Wooden batten below top 2 drawers is loose and broken to 1 edge<br>Light marks and scuffs<br>Chips to edges | |

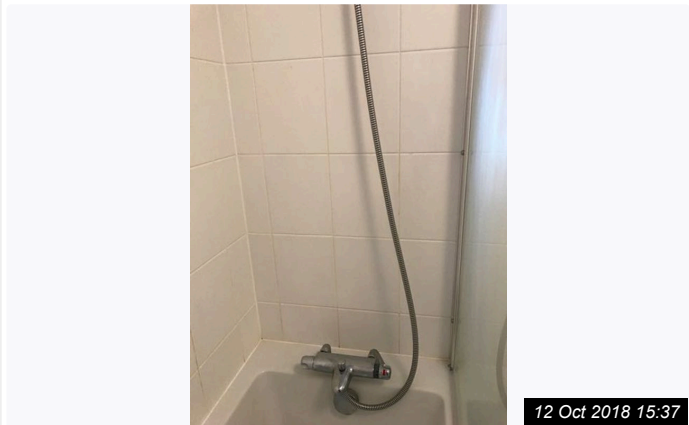
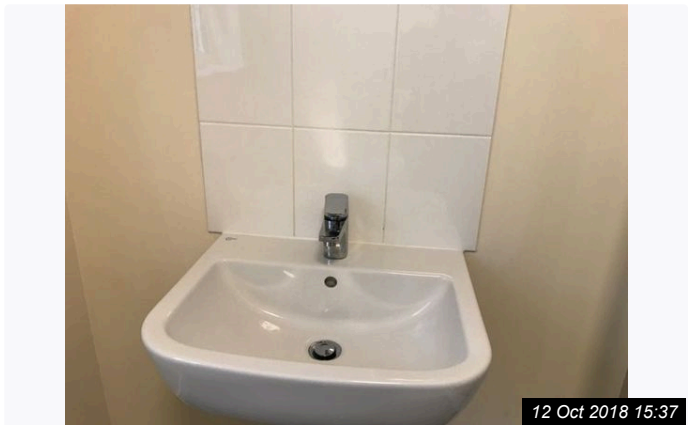
Ref # 10.9

| 10. BATHROOM (CONT.) | | | |
|---|---|---|--|
| 10.9 Tiles | White tiles with white grout | Light discolouration throughout grout above bath and shower<br>No broken tiles noted | |

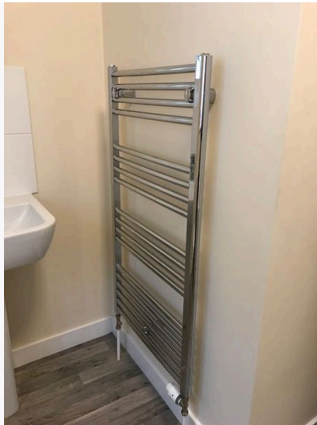
Ref # 10.11

| 10. BATHROOM (CONT.) | | | |
|---|---|---|--|
| 10.11 Heating | Chrome coloured heated towel rail with thermostat | No defects noted | |

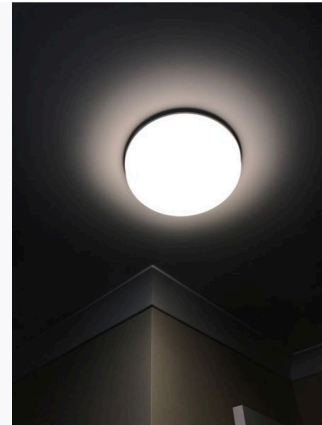
Ref # 10.12

| 10. BATHROOM (CONT.) | | | |
|---|---|---|--|
| 10.12 Lighting | 1 white enclosed ceiling light fitting | No defects noted | |

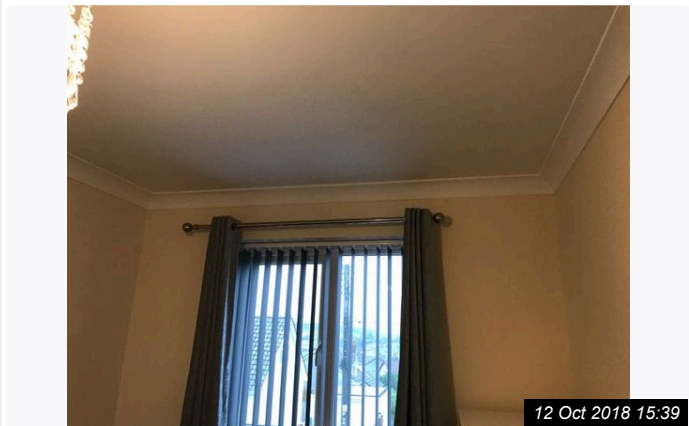
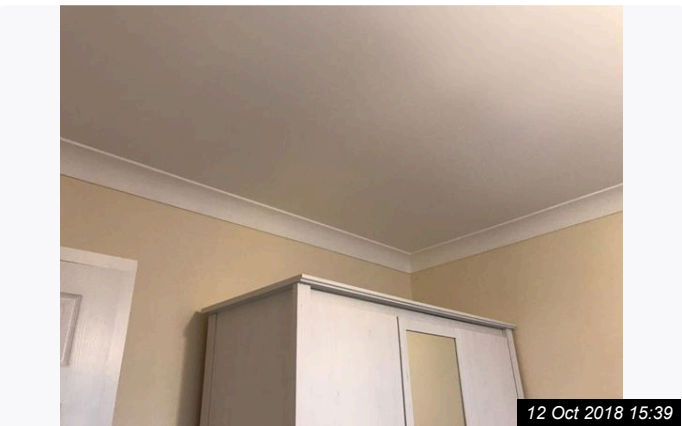
Ref # 11.2

| Item | Description | Condition | Tenant Comments |
|---|---|---|---|
| 11.2 Ceiling | Ceiling is smooth plaster painted white. Coving is painted white | No defects noted | |
