# Inventory & Schedule of Condition

123 Sample Street  
Sample City  
Sampleshire  
AB1 2CD

**April  
23rd 2019**

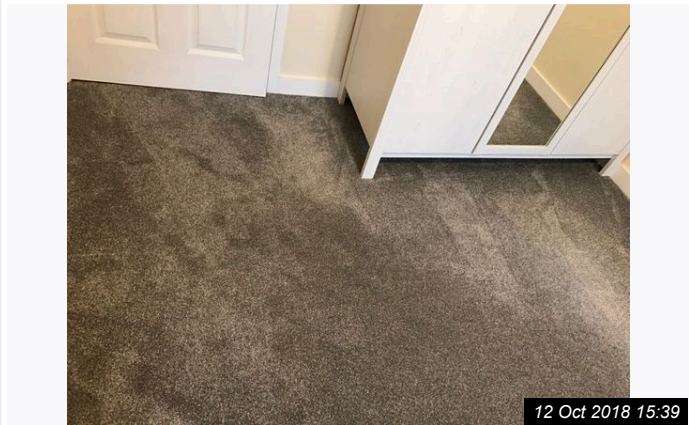
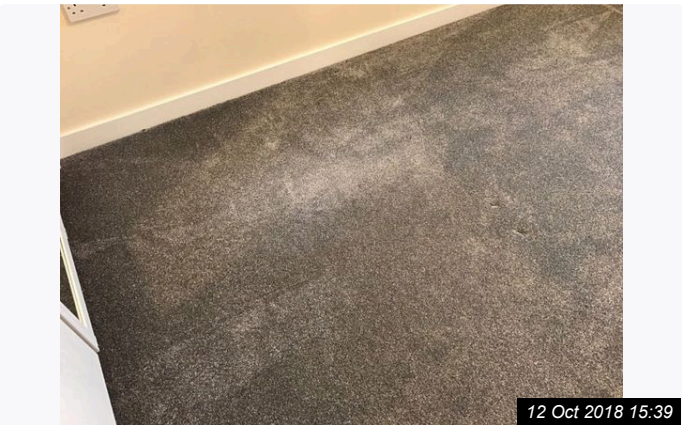
Ref # 11.3

| Item | Description | Condition | Tenant Comments |
|---|---|---|---|
| 11.3 Flooring | Grey fitted carpet | No defects noted | |

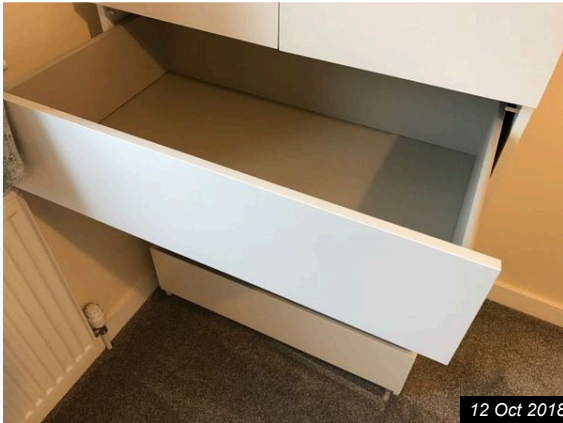
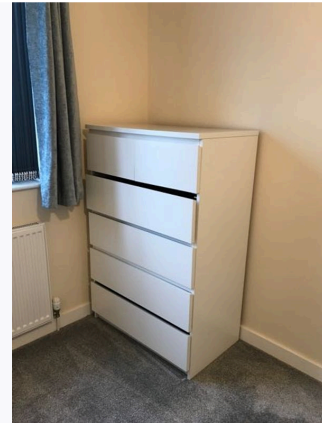
Ref # 11.9

| 11. BEDROOM 3 (CONT.) | | | |
|---|---|---|--|
| 11.9 Drawers | White 6-drawer chest | Dusty inside<br>Gap between 2 top small drawers and lower large drawers | |

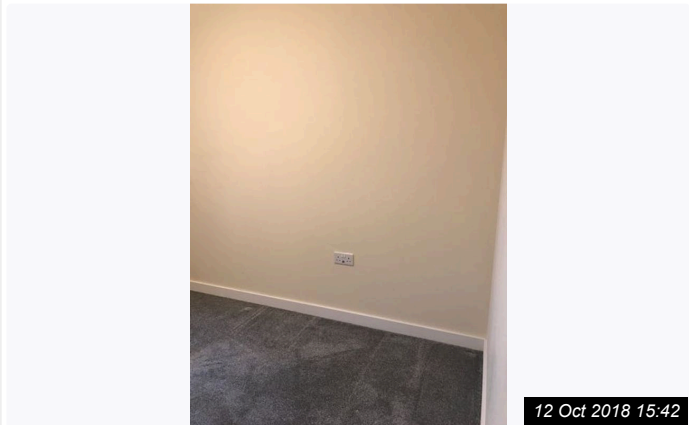
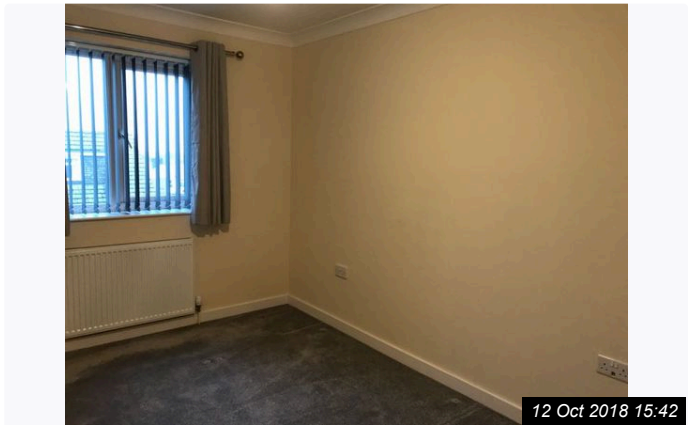
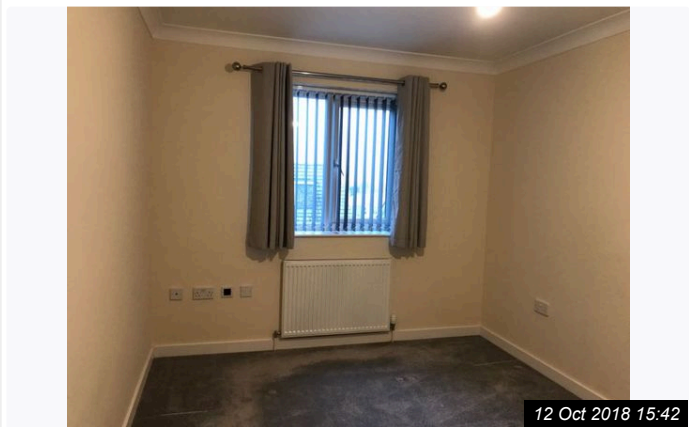
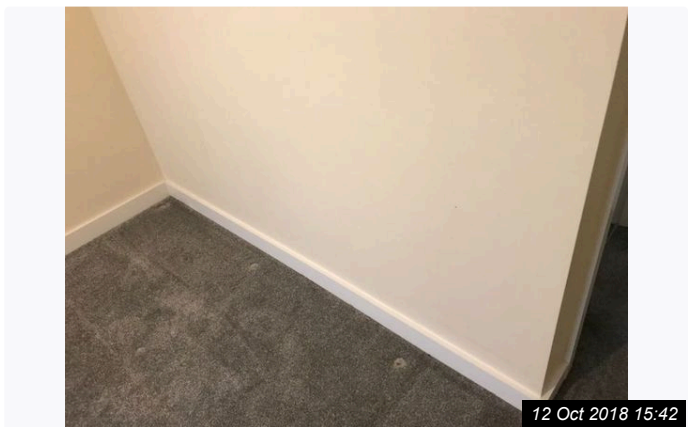
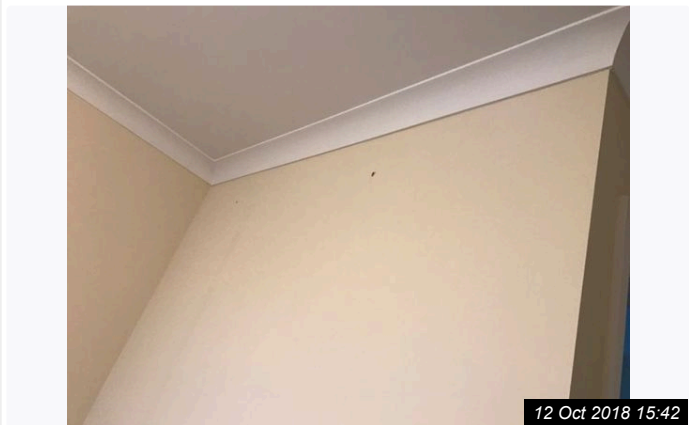
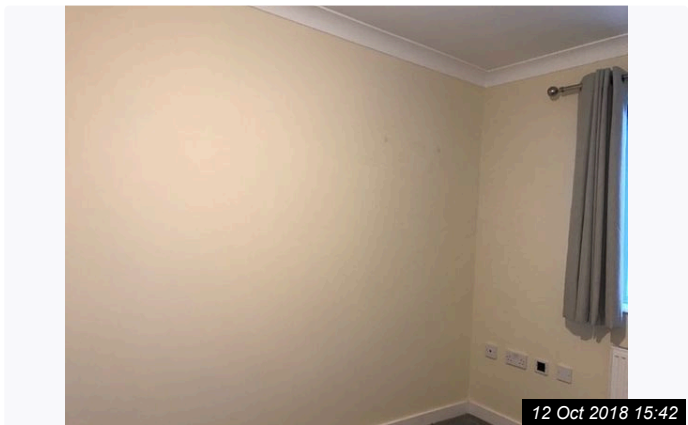
Ref # 12.1

| Item | Description | Condition | Tenant Comments |
|---|---|---|---|
| 12.1 Walls and skirting | Walls are smooth plaster painted cream. Skirting is painted white | 2 metal rawl plugs to near right wall<br>Large painted over defects/fixing holes to far end of left wall<br>Light scuffs and marks to lower walls | |

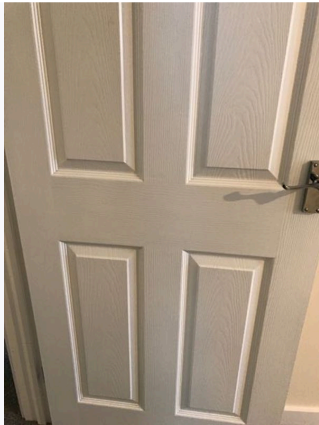
Ref # 12.5

| Item | Description | Condition | Tenant Comments |
|---|---|---|---|
| 12.5 Door and Frame | White wood grain effect panel door with chrome coloured handle<br>Frame is painted white<br>White/chrome coloured double coat hook | No defects noted | |

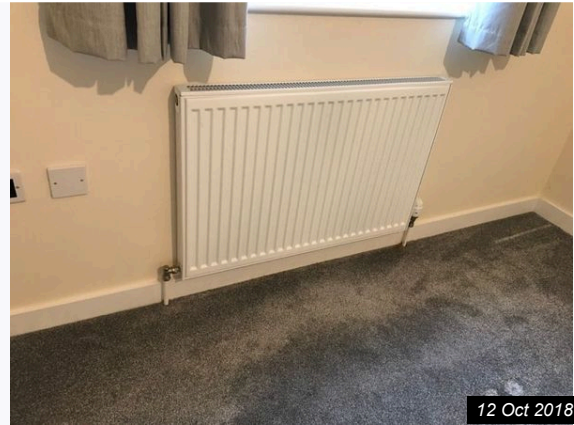
Ref # 12.6

| Item | Description | Condition | Tenant Comments |
|---|---|---|---|
| 12.6 Heating | White single panel radiator with valve and thermostat present | No defects noted | |

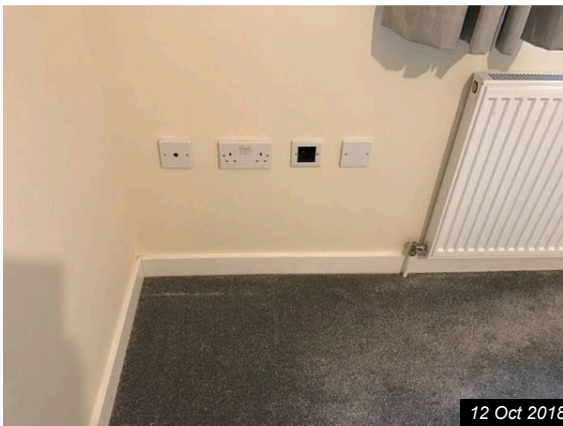
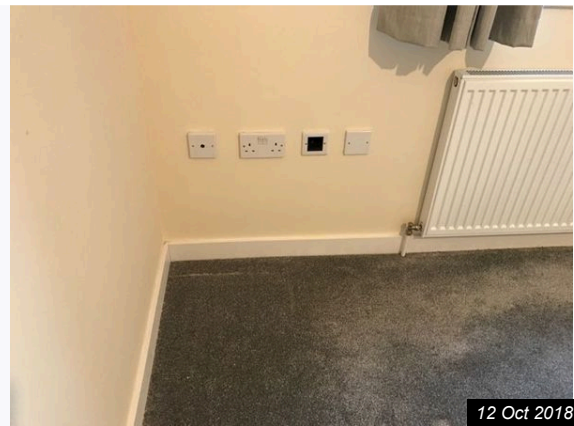
Ref # 12.7

| 12. BEDROOM 4 (CONT.) | | | |
|---|---|---|--|
| 12.7 Lights/Sockets/<br>Switches | 1 white plastic pendant light fitting with bulb<br>1 single light switch<br>1 doorstop<br>1 double socket with USB<br>3 double sockets<br>1 TV aerial point<br>1 single plain face plate<br>1 socket for cables | No defects noted<br>Light is operational | |

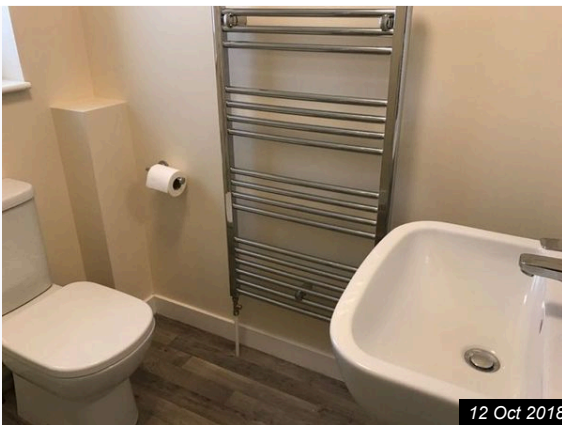
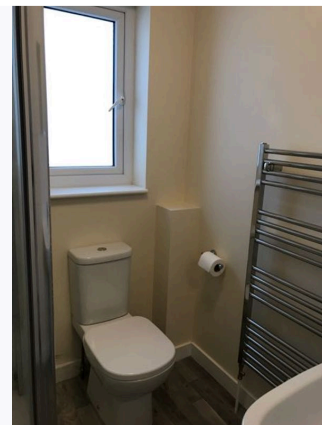
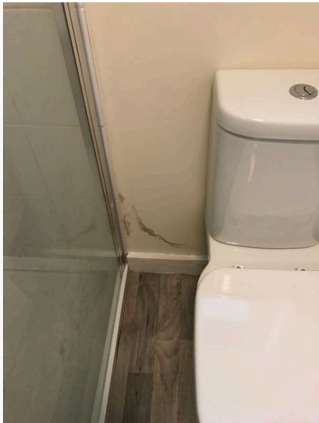
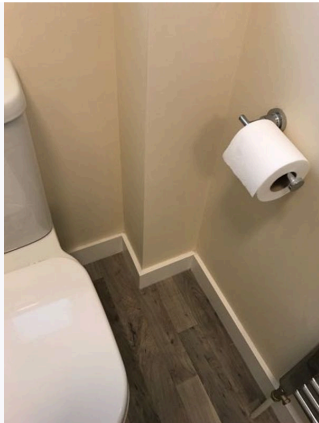
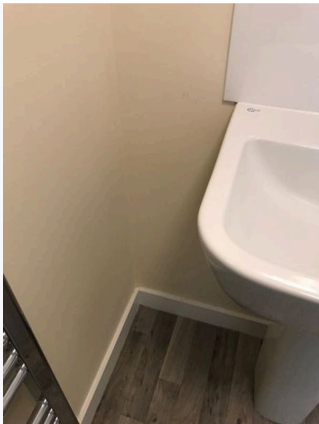
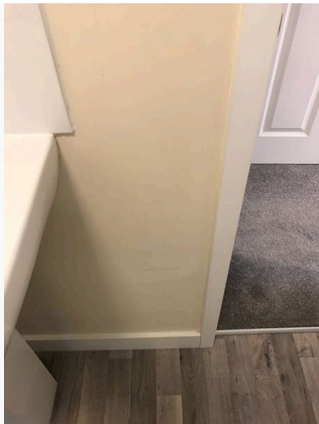
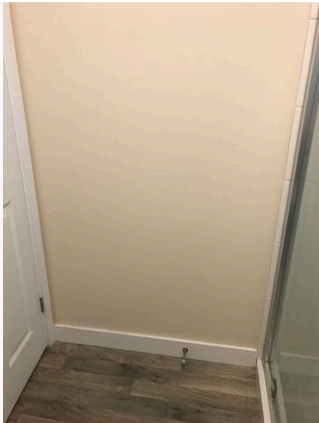
Ref # 13.1

| Item | Description | Condition | Tenant Comments |
|---|---|---|---|
| 13.1 Walls and skirting | Walls are smooth plaster painted cream. Skirting is painted white | Staining to skirting by WC<br>Large area of brown discolouration to left of WC - 30cm<br>Light scuffs and water marks to left of basin<br>Painted over indentation to left of door - 15cm | |

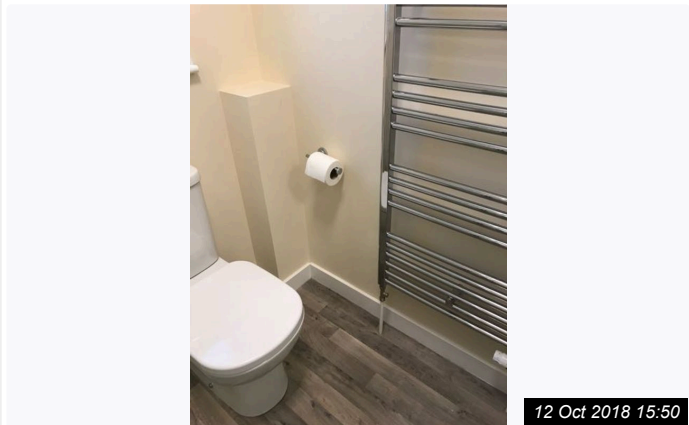
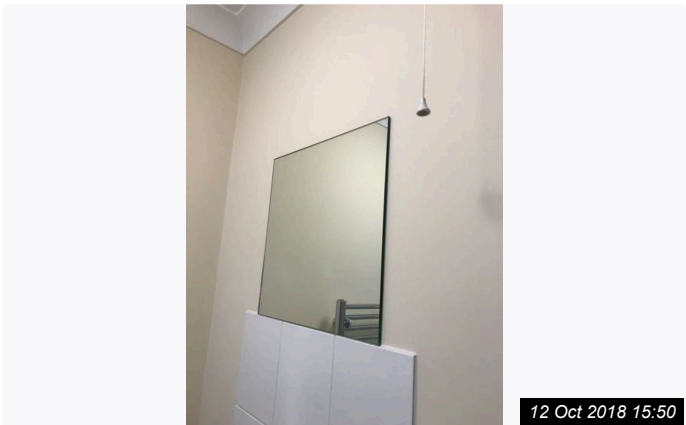
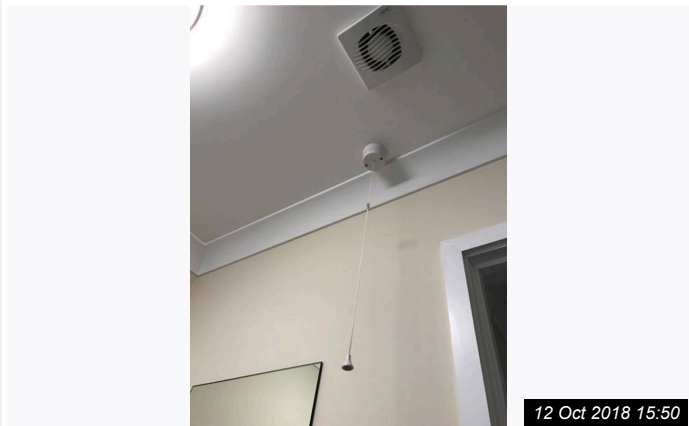
Ref # 13.9

| 13. EN SUITE (CONT.) | | | |
|---|---|---|--|
| 13.9 Fixtures/Fittings | 1 chrome coloured toilet roll holder<br>1 mirror<br>1 light pull switch<br>1 ceiling mounted extractor fan | No defects noted | |

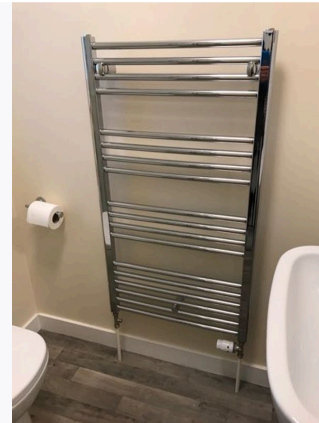
Ref # 13.11

| 13. EN SUITE (CONT.) | | | |
|---|---|---|--|
| 13.11 Heating | Chrome coloured heated towel rail with thermostat | No defects noted | |

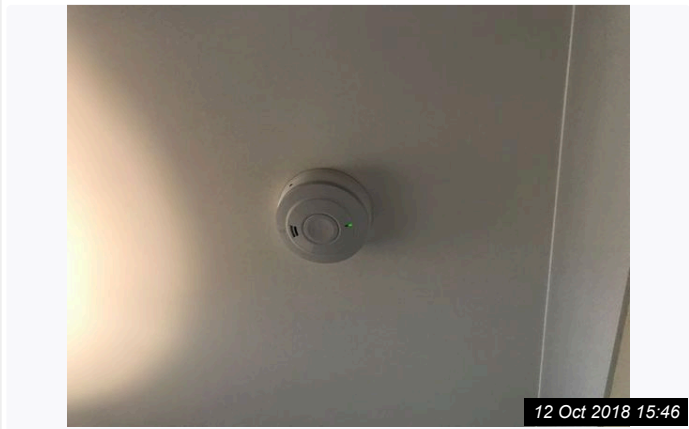
Ref # 15.1

| Question | Answer | Comments | Tenant Comments |
|---|---|---|---|
| 15.3 Do the alarms sound when test button is pressed? | Yes | | |

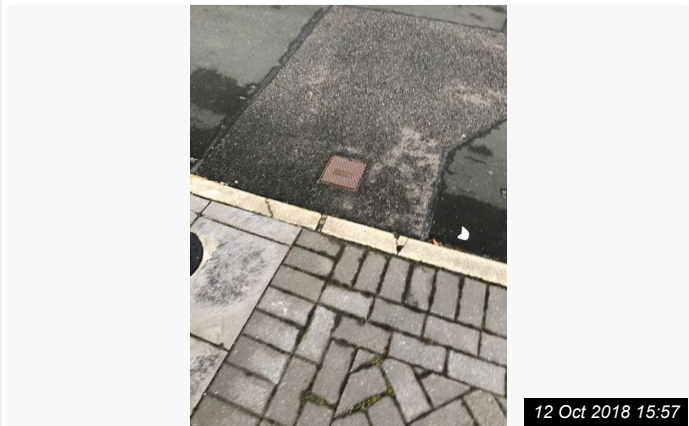
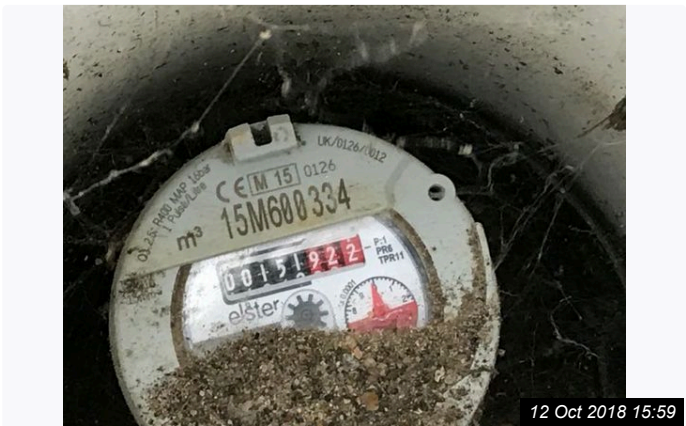
Ref # 16.3 - 15M600334 00151

| Item | Serial Number | Reading | Tenant Comments |
|---|---|---|---|
| 16.3 Water Meter | In front footpath. 15M600334 | 00151 | |
